Changes and Bug Fixes since 1.101:

Bose® ControlSpace™ **V1.2 Release Notes**

File Open/Upload Errors

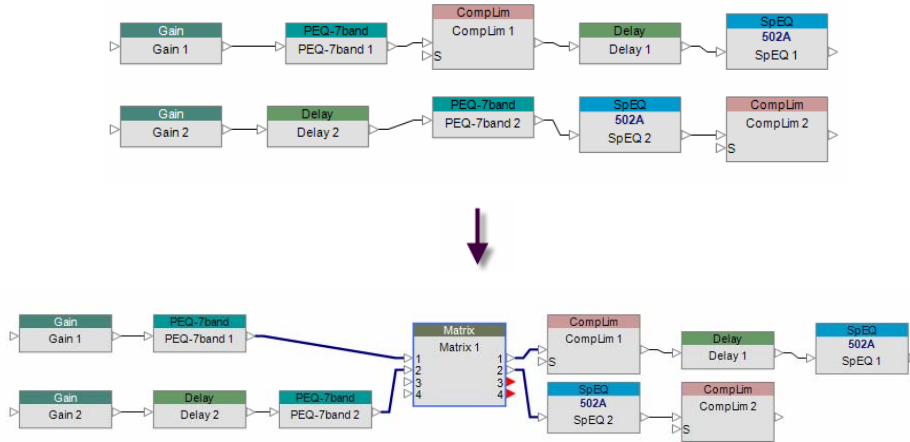
Insert pass through matrix.

1. Gather/combine similar processing blocks; Ex. 4 2x1 mixer can be combined into an 8x8 mixer.
2. Try a pass-through matrix to change the signal flow order.

3. Place signal processing blocks in the same order; instead of processing similar modules at different times, process all similar modules together. Also, the order that certain modules are processed can affect uploading. An example is having compressors directly before output modules, which can cause upload errors.
