Bose® ControlSpace® Designer™ Software
ControlSpace 1.1 Release Notes

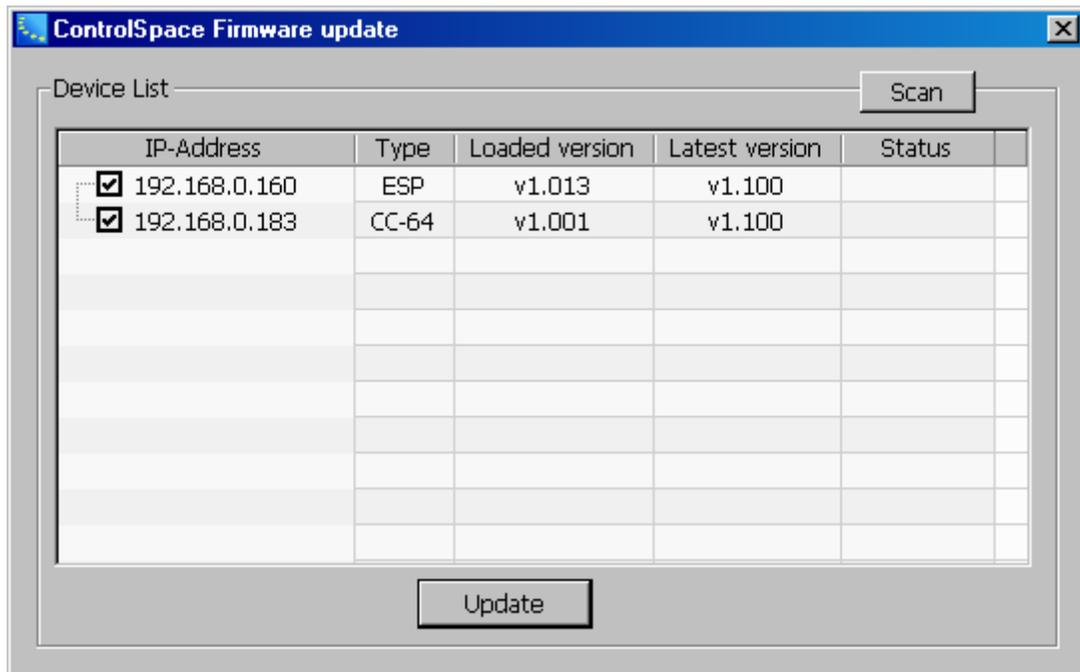
Note that the application automatically:

- scans for the hardware,
- determines the firmware currently loaded,
- determines the latest firmware in the bin directory,
- selects (check marks) the devices for which a firmware update is recommended.

4. Click update to start the firmware update process.

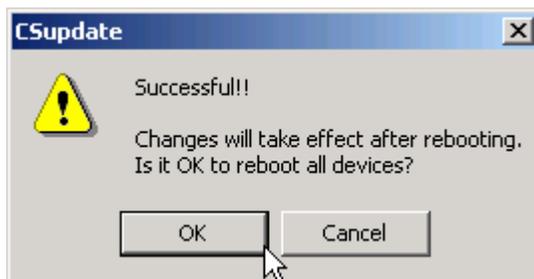
5. If successful, the following dialog should appear.

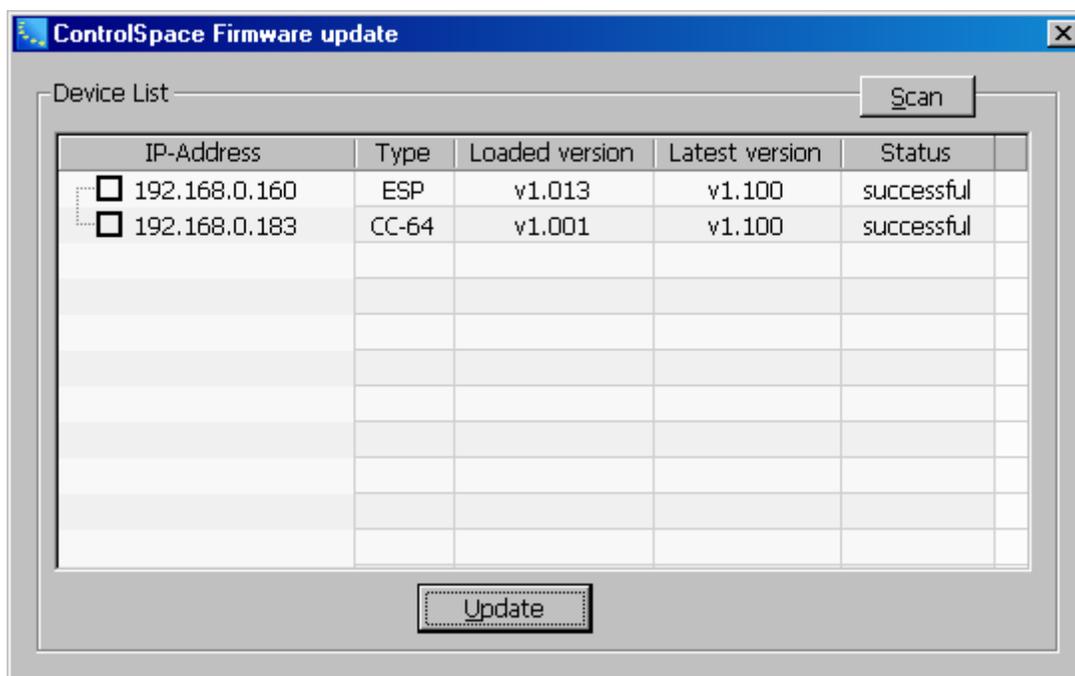
6. After clicking OK, the status will be updated to successful; you should have a dialog similar to the one below:

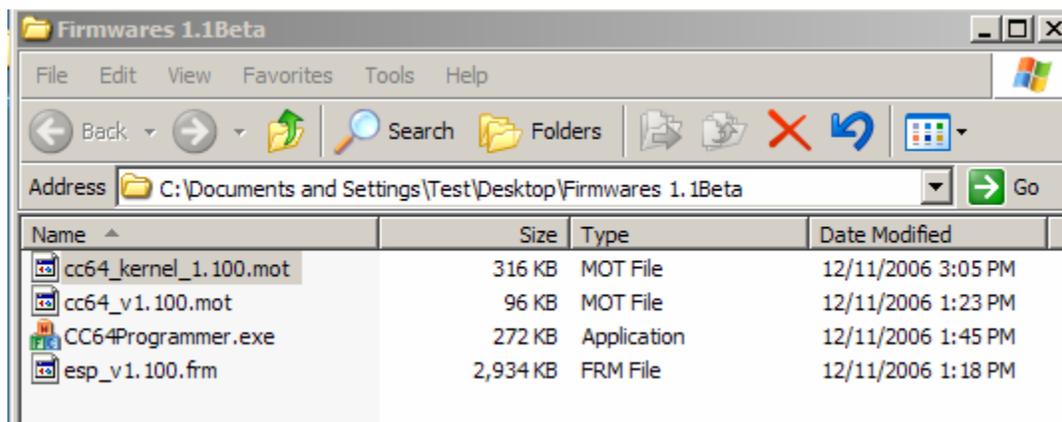
1. Copy the CC-64 Programmer.exe to your drive. Copy CC-64_kernel_1.100.mot and CC-64_v1.100.mot (firmware) to the same location. See the figure below:

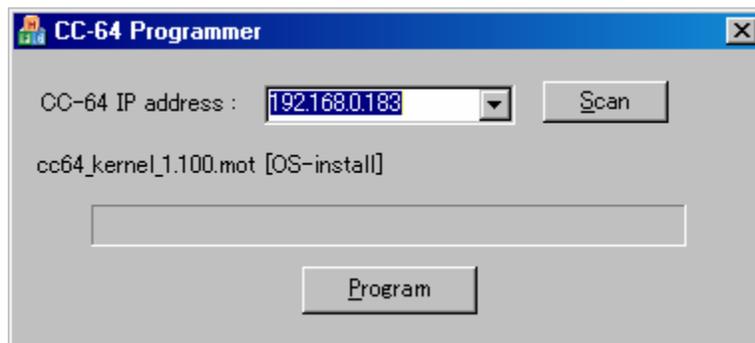
2. Start CC-64 Programmer. Drag and drop the file CC-64_kernel_1.100.mot onto the CC-64 programmer screen.

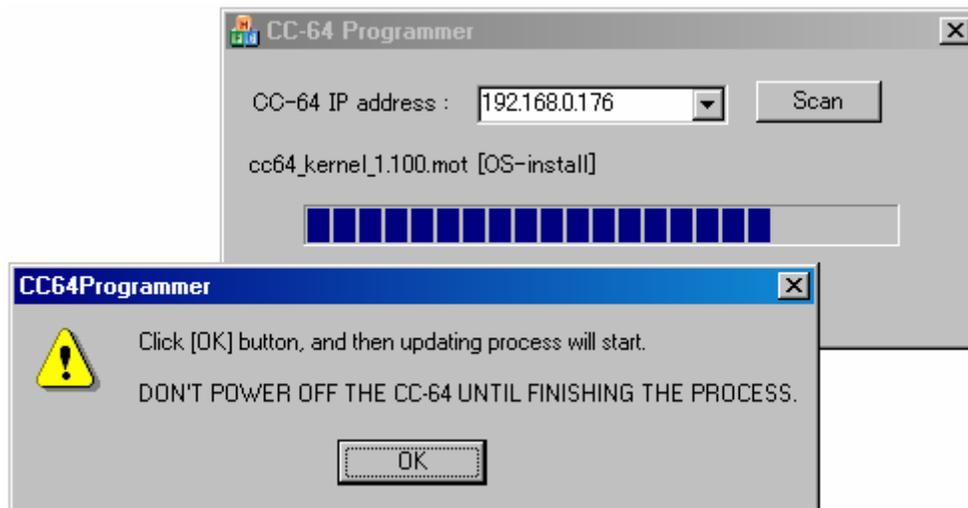
4. After about 45 seconds, a dialog will appear, reminding you not to power off the CC-64 while the device is being flashed. Press OK.

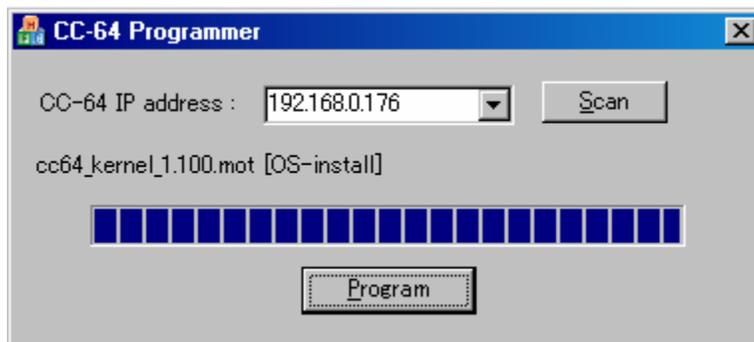
5. When the blue status meter reaches the end, as shown below, check the LCD of the CC-64. There will be a series of changing numbers on the top line.

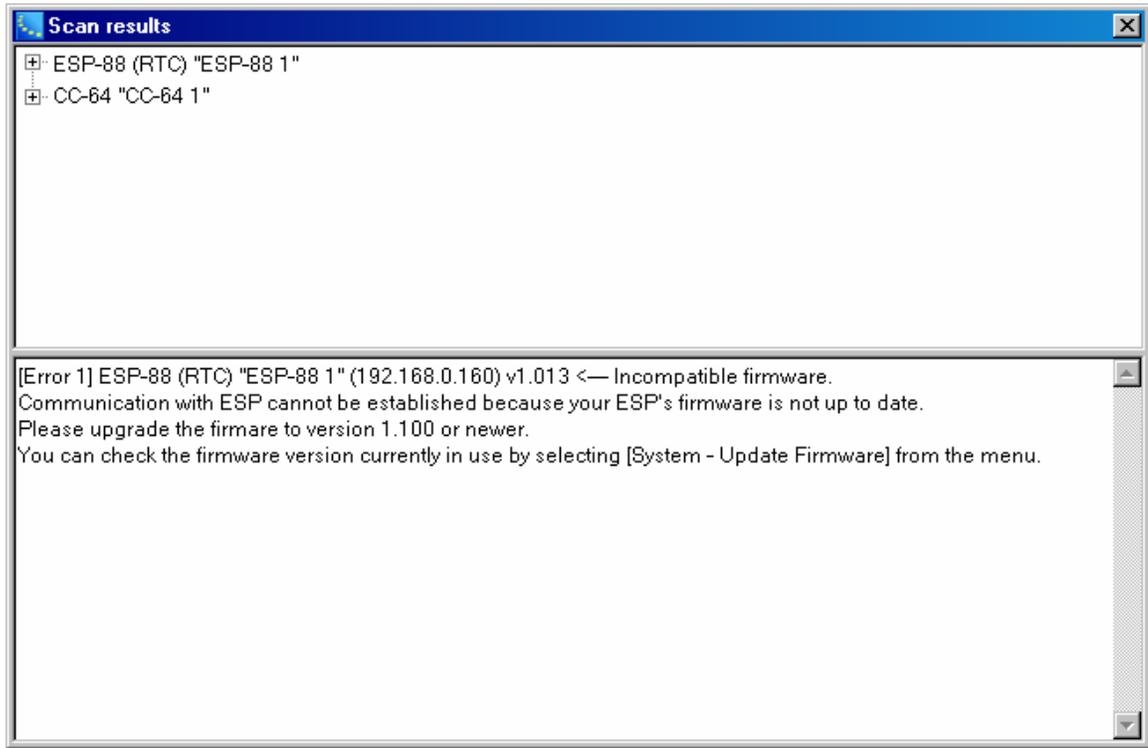
If you receive a dialog box similar to the one below after pressing Scan, it is an indication you need to upgrade your firmware. Follow the instructions above to upgrade the firmware.
