# BOSE<sup>®</sup> PRODUCT IMPROVED COMBAT VEHICLE CREWMAN (PICVC) ACTIVE NOISE REDUCTION HEADSET USE AND MAINTENANCE MANUAL

US Army Training Manual, Rev. 1.0 – Oct, 2007

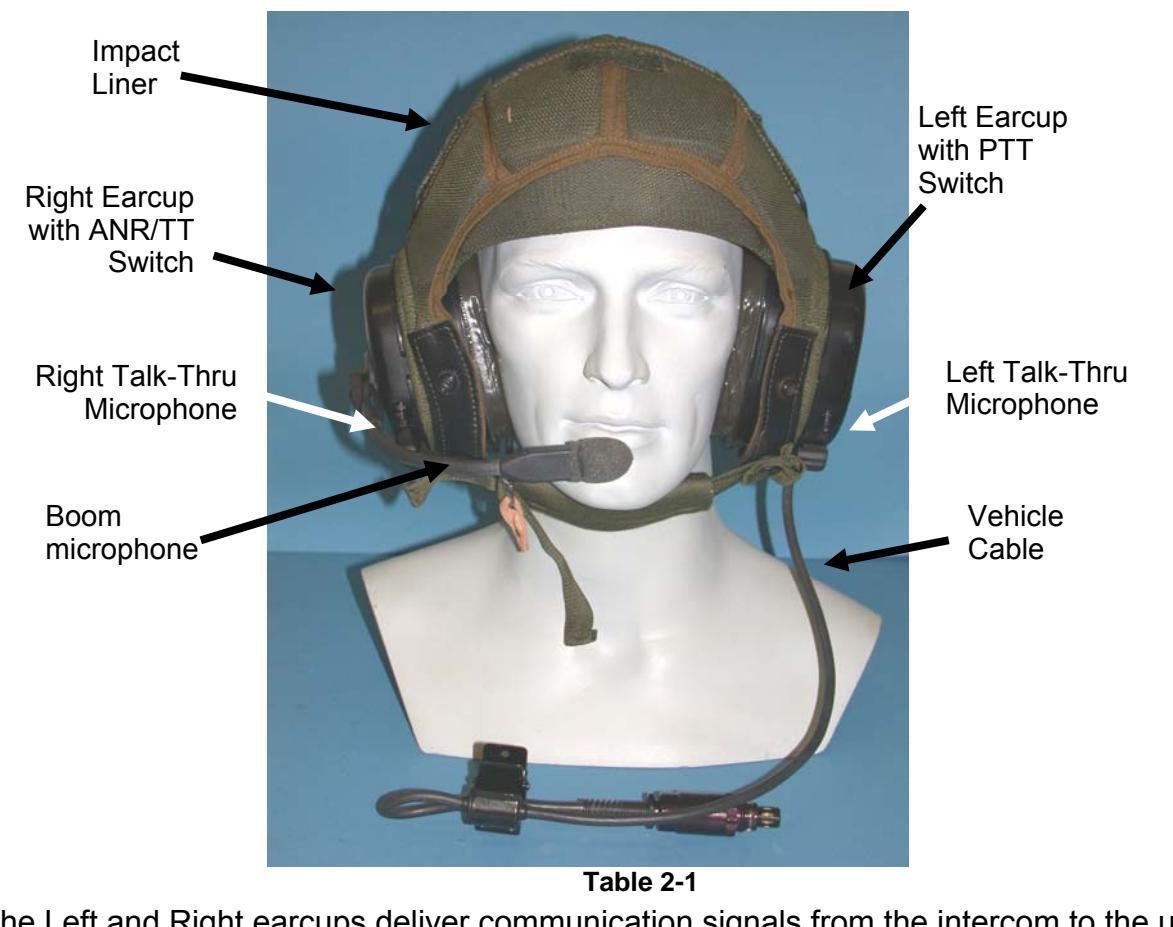
As shown in the picture below, the headset includes Left and Right earcups. Foam ear cushions in the earcups seal them to a user's head. A boom microphone is mounted on the Right earcup. A vehicle cable connected to the Left earcup is used to connect the headset to an intercom. The earcups are connected by an earcup cable which is not visible in the picture. The earcups are mounted in an impact liner for mounting on a user's head.

The Left and Right earcups deliver communication signals from the intercom to the user's ears. In addition, through the use of the ear cushions and proprietary electronic circuitry, they provide

passive and active noise reduction (or attenuation). The boom microphone delivers the user's speech to the intercom. There is also a talk-thru microphone mounted on each earcup to permit communication while disconnected from the intercom.

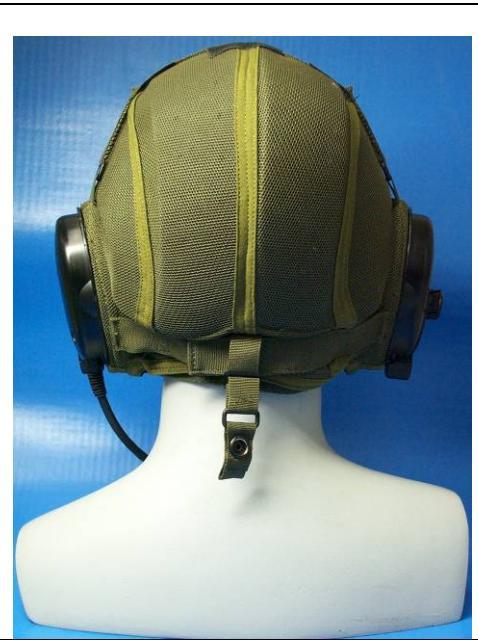
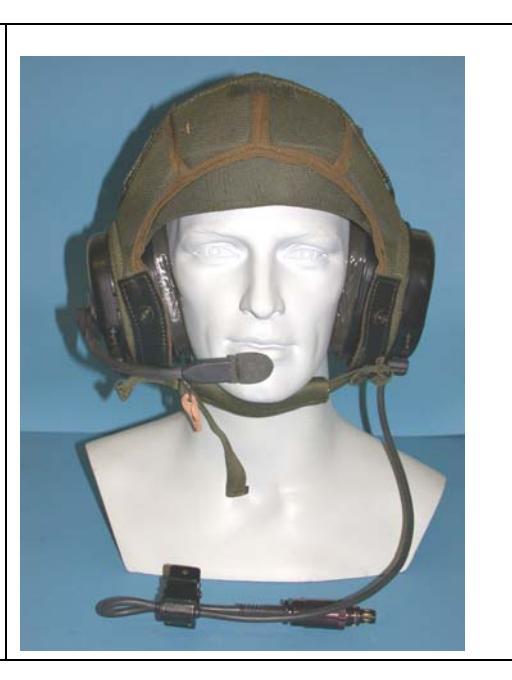
Figure 3-1

- 3.1.1 If this is the initial fitting of the headset, release the Velcro straps on the impact liner above each earcup and across the back at your neck (nape adjustment). Place the impact liner on your head with each ear entirely within the corresponding ear cushion.
- 3.1.2 Rotate the earcups, as required, to provide as much comfort as possible with the ear cushions tight against your head.
- 3.1.3 Take up slack in the Velcro straps at the back of your neck and then the straps above the earcups, Figure 3-1. Adjust tension so that the ear cushions are tight against your head with each ear totally enclosed within the ear cushion.

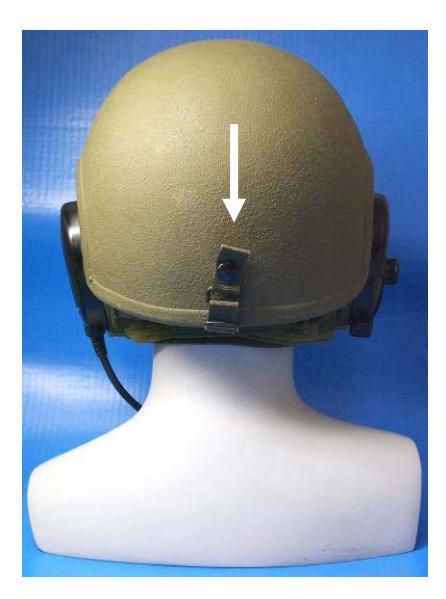
Figure 3-3

- 3.1.4 Place the outer shell over the impact liner so the rubber edging of the forehead portion of the outer shell is even with the edge of the browpad on the impact liner.
- 3.1.5 Push down on the outer shell to engage the Velcro patch on the top of the impact liner and the Velcro patch inside the outer shell.
- 3.1.6 Attach the snap fastener at the rear of the impact liner to the fastener at the rear of the outer shell, Figure 3-3.

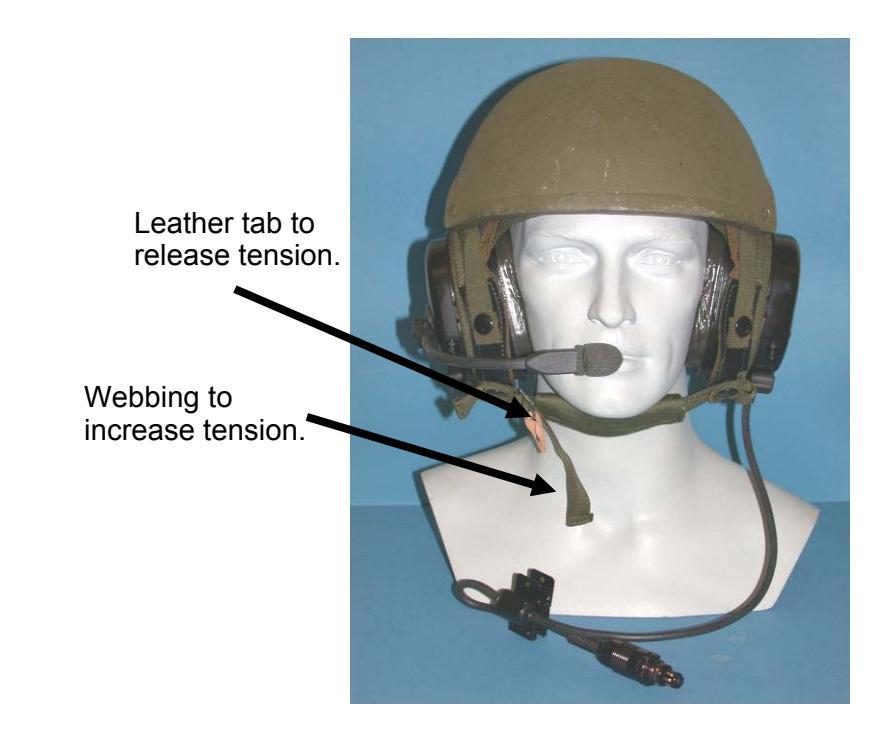
To increase tension, pull on the webbing attached to the buckle; to release tension, pull the leather tab attached to the buckle, Figure 3-4

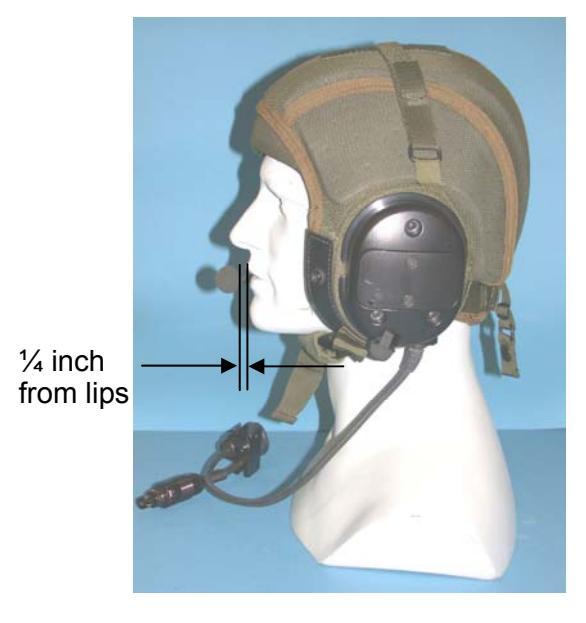
3.1.8 Adjust the boom microphone to place the microphone directly in front of the mouth, 1/4 inch from lips, Figure 3-5.

The Microphone must be close to your lips for effective communication.

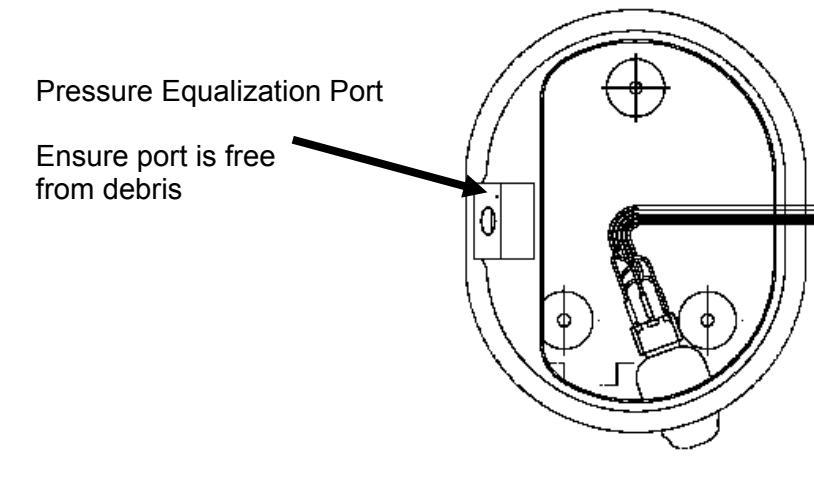
Figure 4-2

COMPONENT	CONDITION	CORRECTIVE ACTION cloth.
Outer Earcup	Cracks or other visible damage to housing.	Replace outer earcup assembly. (Appendix II, Section 7)
	Pressure equalization port dirty. (See Figure 4-2)	Clear pressure equalization port with a small wire or a paper clip.
		CAUTION
		Do not insert wire deeper than 1/2 inch (12.7 mm).
	Outer surface dirty or dusty.	Clean with water and damp cloth.
Switch Assembly	Bent or broken shaft, lack of latching, or momentary action.	Replace switch assembly. (Appendix II, Section 5)
	Paddle broken or missing.	Replace paddle.
Earcup Cable	Cuts, kinks, or fraying.	Replace earcup cable assembly. (Appendix II, Section 8)
Vehicle Cable	Cuts, kinks, fraying or damage or corrosion to connector.	Replace vehicle cable assembly. (Appendix II, Section 6)
boom microphone Assembly	Cuts, kinks, or fraying of cable or damage to connectors.	Replace boom microphone assembly. (Appendix II, Section 4)

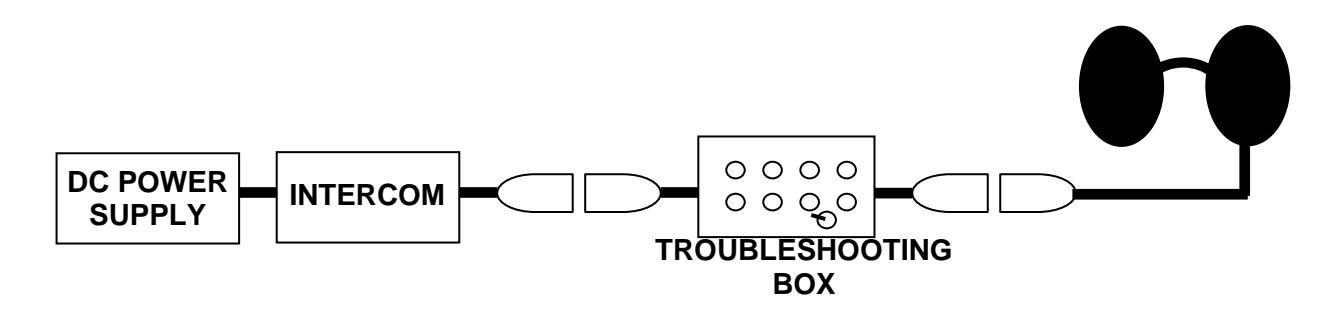
Figure 5.3.2-1 Equipment Setup for Testing

- 5.4.1 Connect the HUT to the test box and connect the test box to a functioning intercom.
- 5.4.2 Check for 24VDC between TP7 and TP3 on the test box. If no 24VDC, verify operation of the intercom.
- 5.4.3 Else, proceed to Section 6 and troubleshoot Both Earcups; Faulty Communication or ANR.
- 5.5 Operating Current Verification. Operating current must be verified before performance verification to ensure that power connections in the headset are correct.
- 5.5.1 Set the power supply voltage to 24 +0/-1 Vdc and power supply current limit to 200mA.
- 5.5.2 Connect the Headset Under Test (HUT) as shown in Figure 5.3.2-1.

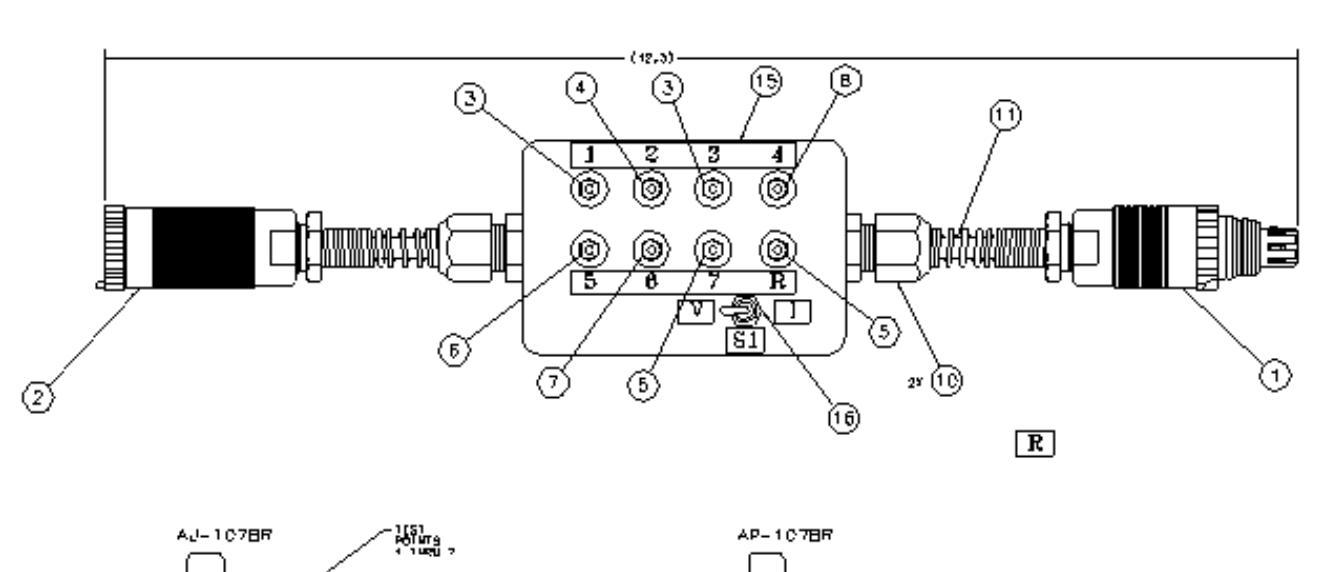
Table 5.3.2-2 Vehicle Cable Connections

PIN0U1			
PIN	тір јаск	TEST POINT	
1	BLACK	DRAIN	
2	WHITE	PTT	
3	BLACK	GND	
4	GREEN	MIC GND	
5	BLVE	L & R AUDIO	
6	RED	MICSIG	
7	YELLOW	POWER	
R	YELLOW	CURRENT

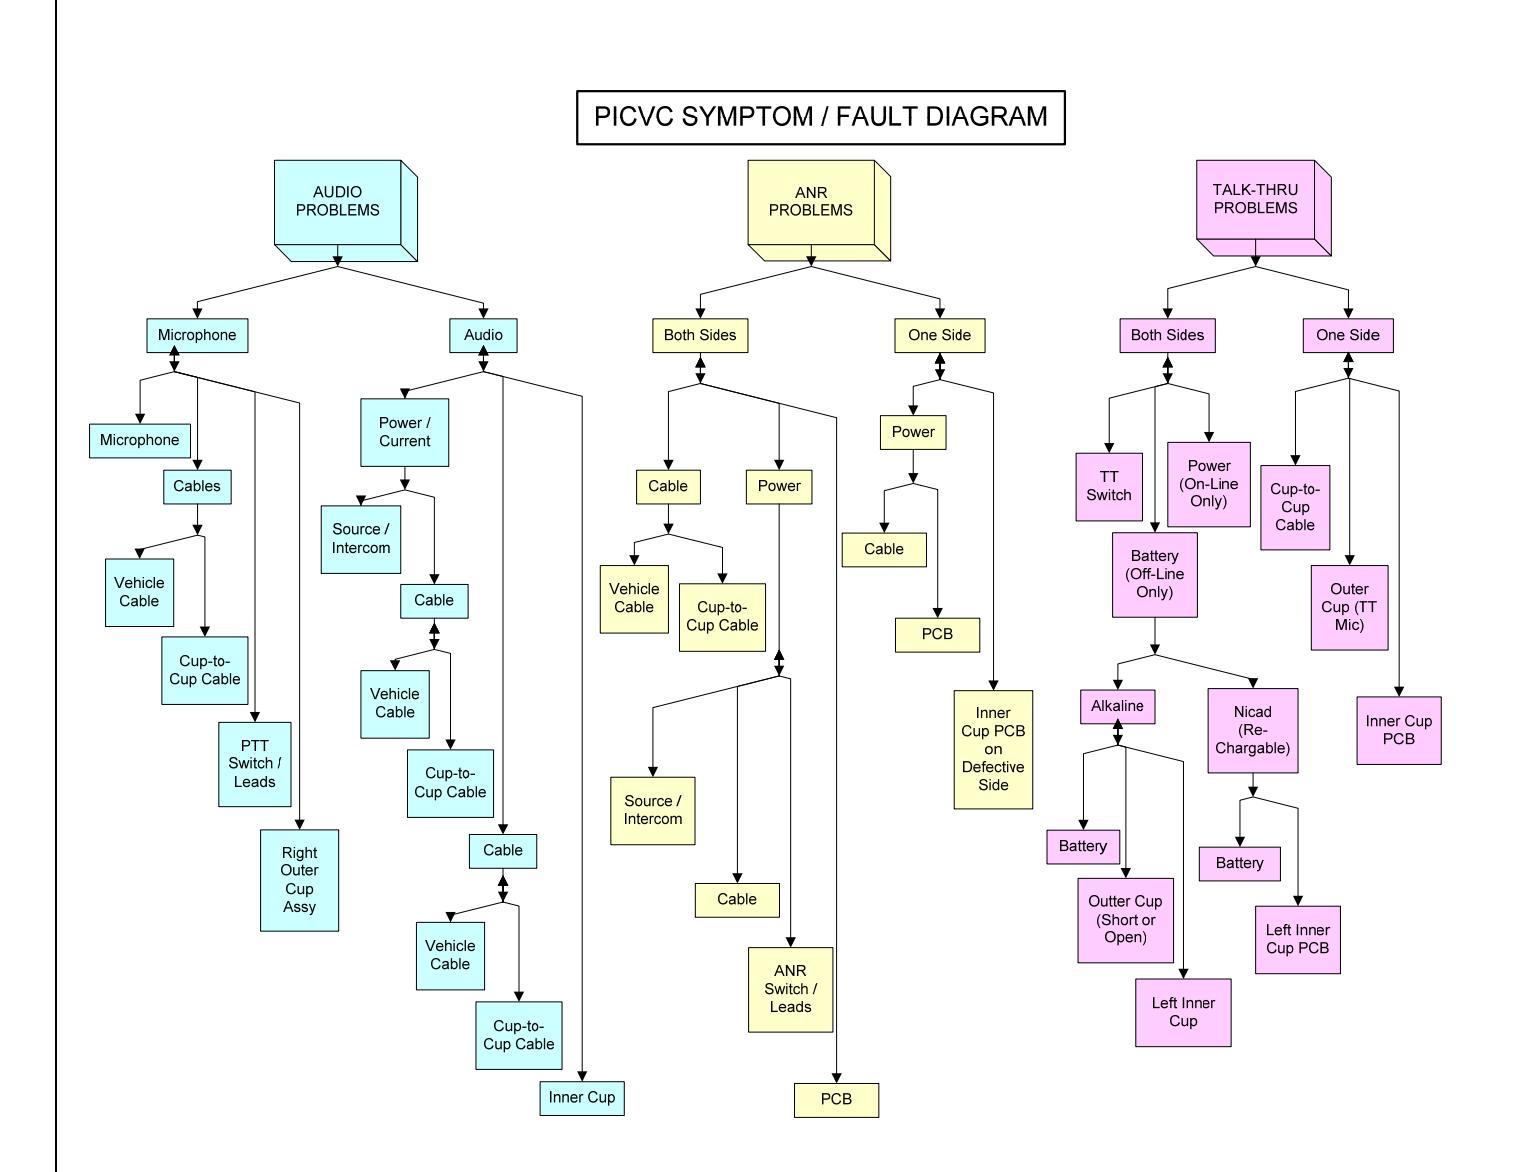
### 6.8 Symptom / Fault Troubleshooting Tree Diagram:

- 6.5 Removal and replacement of the Headset Components for Fault Isolation and Repair
- 6.6 Symptom / Fault Troubleshooting Tree. This tool is intended identify the likely faulty components for the major symptom categories. This chart, used in conjunction with the Fault Isolation and Repair procedures will make the troubleshooting experience more efficient.

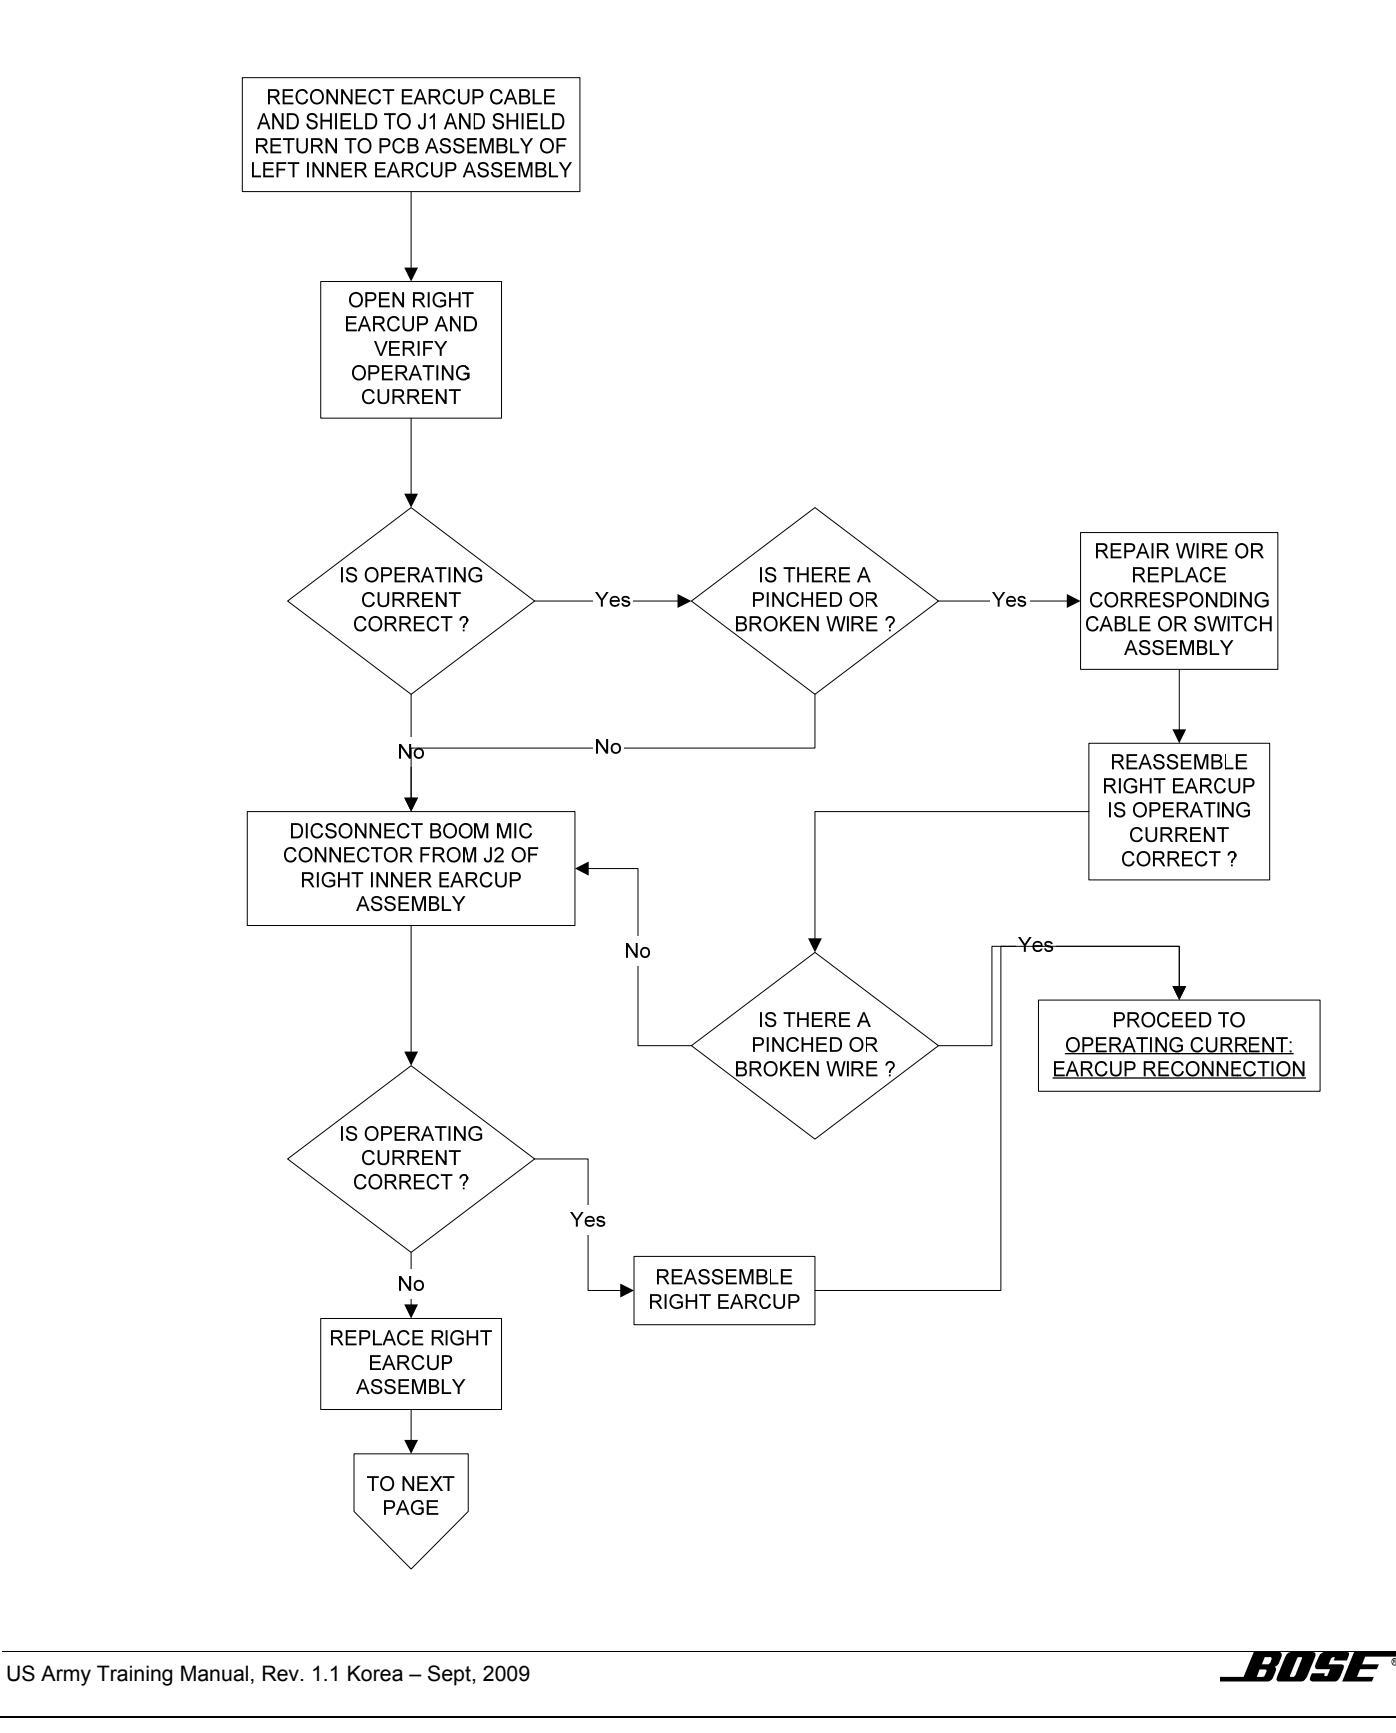
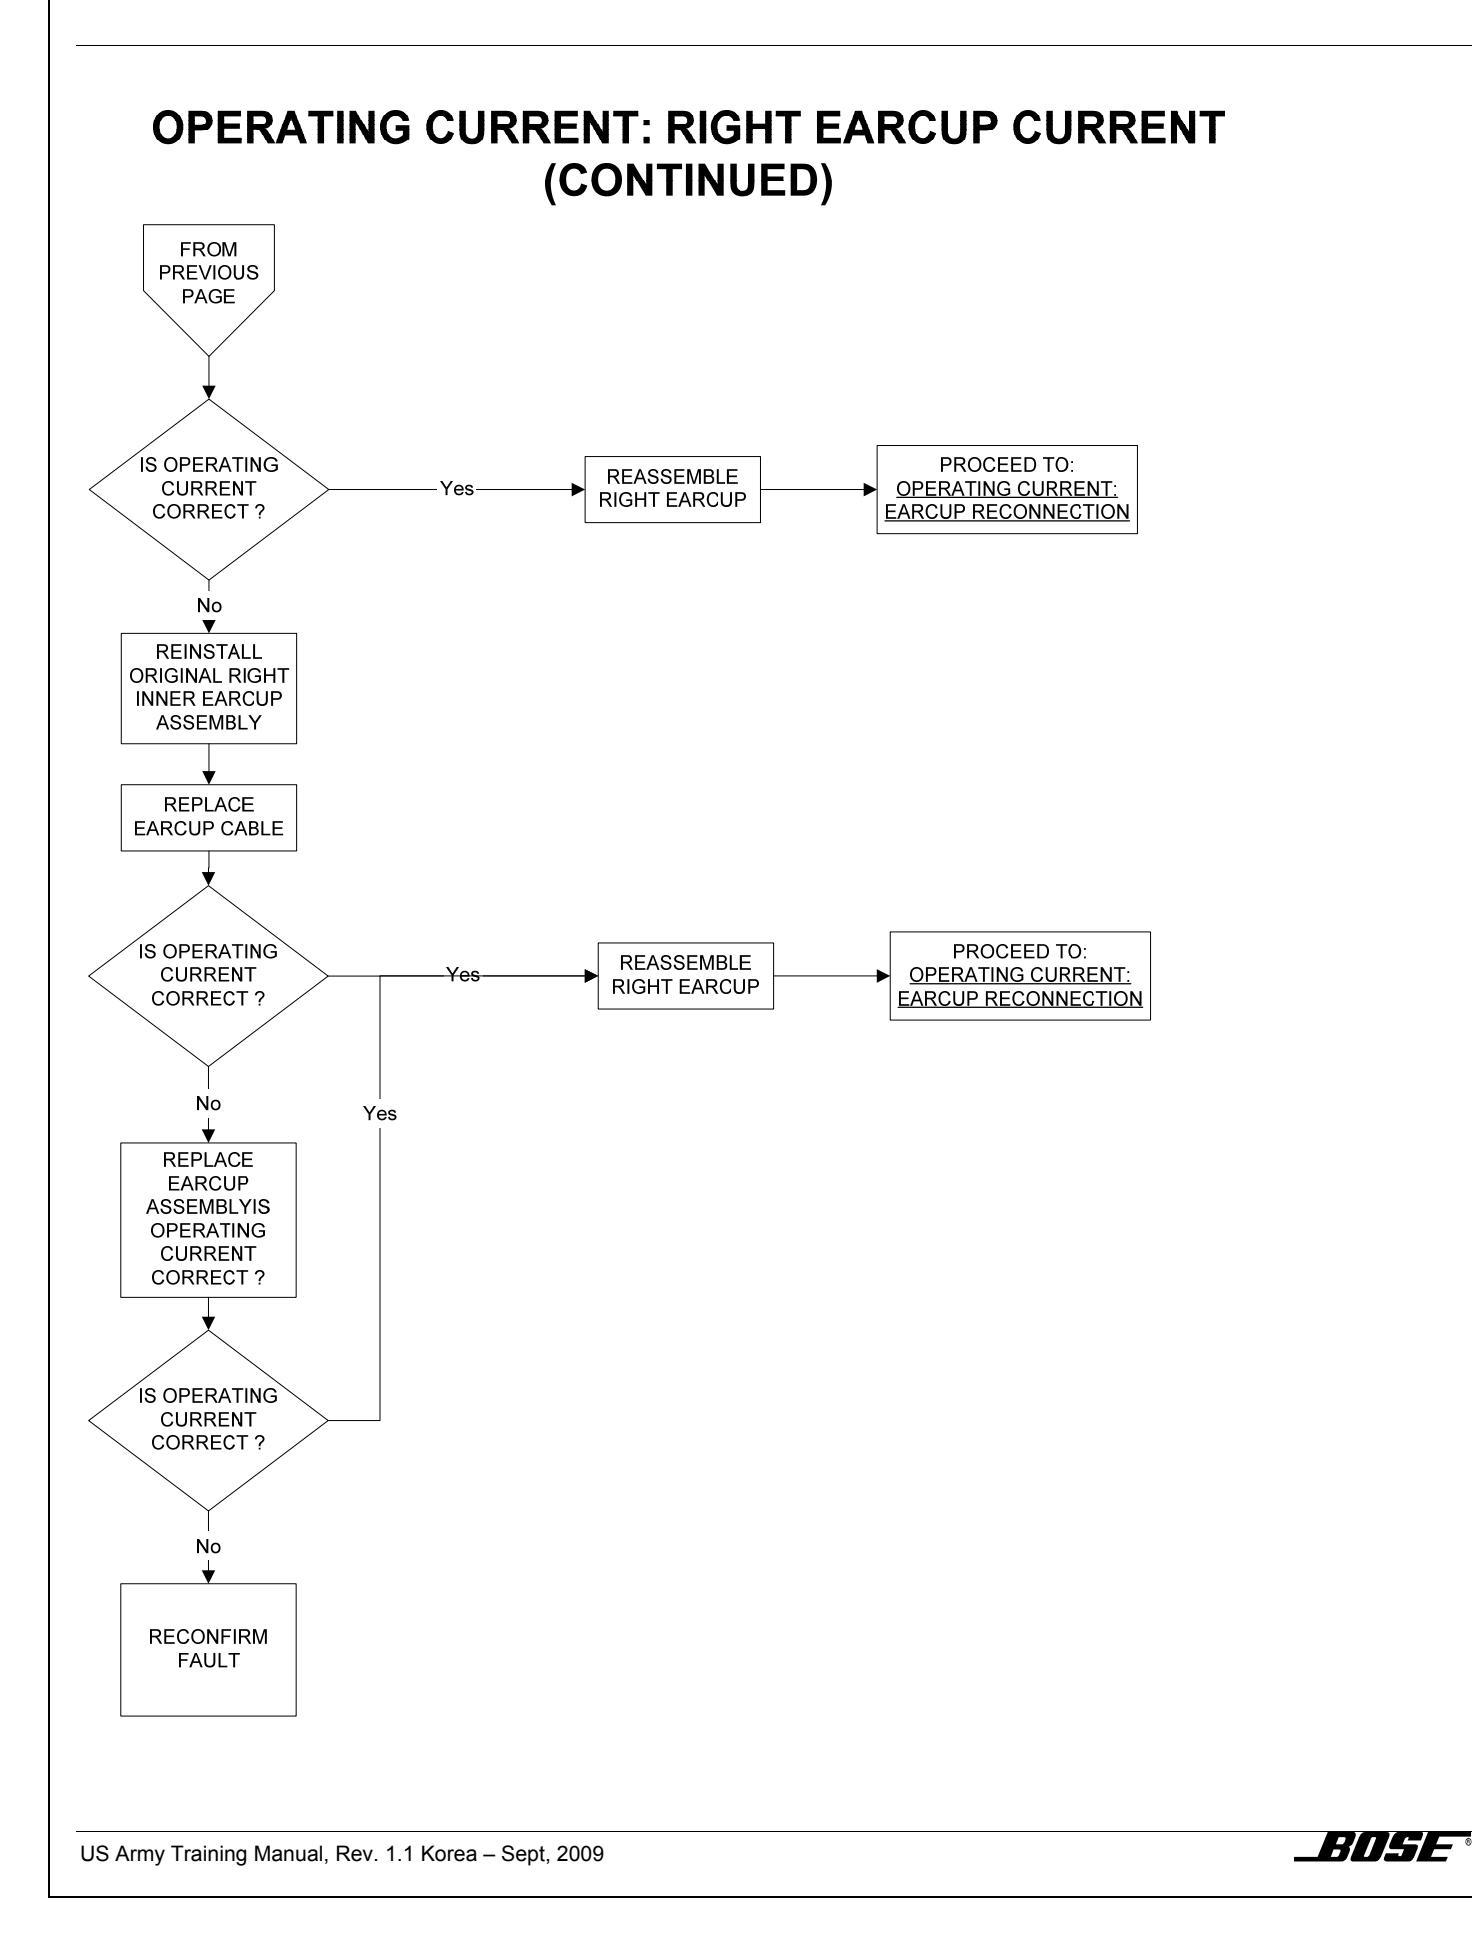
# **OPERATING CURRENT: RIGHT EARCUP CURRENT**

Operating Current: Right Earcup Current	Reconnect earcup cable and shield to J1 and shield return (purple wire) of PCB assembly of Left inner earcup assembly. Then open Right earcup and verify operating current.
	NOTE: It is not necessary to reassemble earcups before this fault is corrected, as long as they are handled gently enough to avoid stressing any of the headset wiring.
	If current correct, suspect pinched wire in Right earcup; locate pinched wire, repair wire or replace corresponding cable or switch assembly, and reassemble Right earcup.
	If current correct, proceed to Operating Current: Earcup Reconnection.
	Otherwise, open Right earcup if closed and disconnect Boom Mic connector from J2 (ref: Apx II, pg-13) of PCB assembly of Right inner earcup assembly.
	If current is in the range 45 to 62 mA, replace earcup assembly.
	If current correct, reassemble Right earcup and proceed to <u>Operating</u> <u>Current: Earcup Reconnection</u> .

Otherwise replace earcup assembly.
	If current correct, reassemble Right earcup and proceed to <u>Operating</u> <u>Current: Earcup Reconnection</u> .
	Otherwise, reinstall original Right inner earcup assembly and replace earcup cable.
	If current correct, reassemble Right earcup and proceed to <u>Operating</u> <u>Current: Earcup Reconnection</u> .
	Otherwise, replace earcup assembly.
	If current correct, reassemble Right earcup and proceed to <u>Operating</u> <u>Current: Earcup Reconnection</u> .

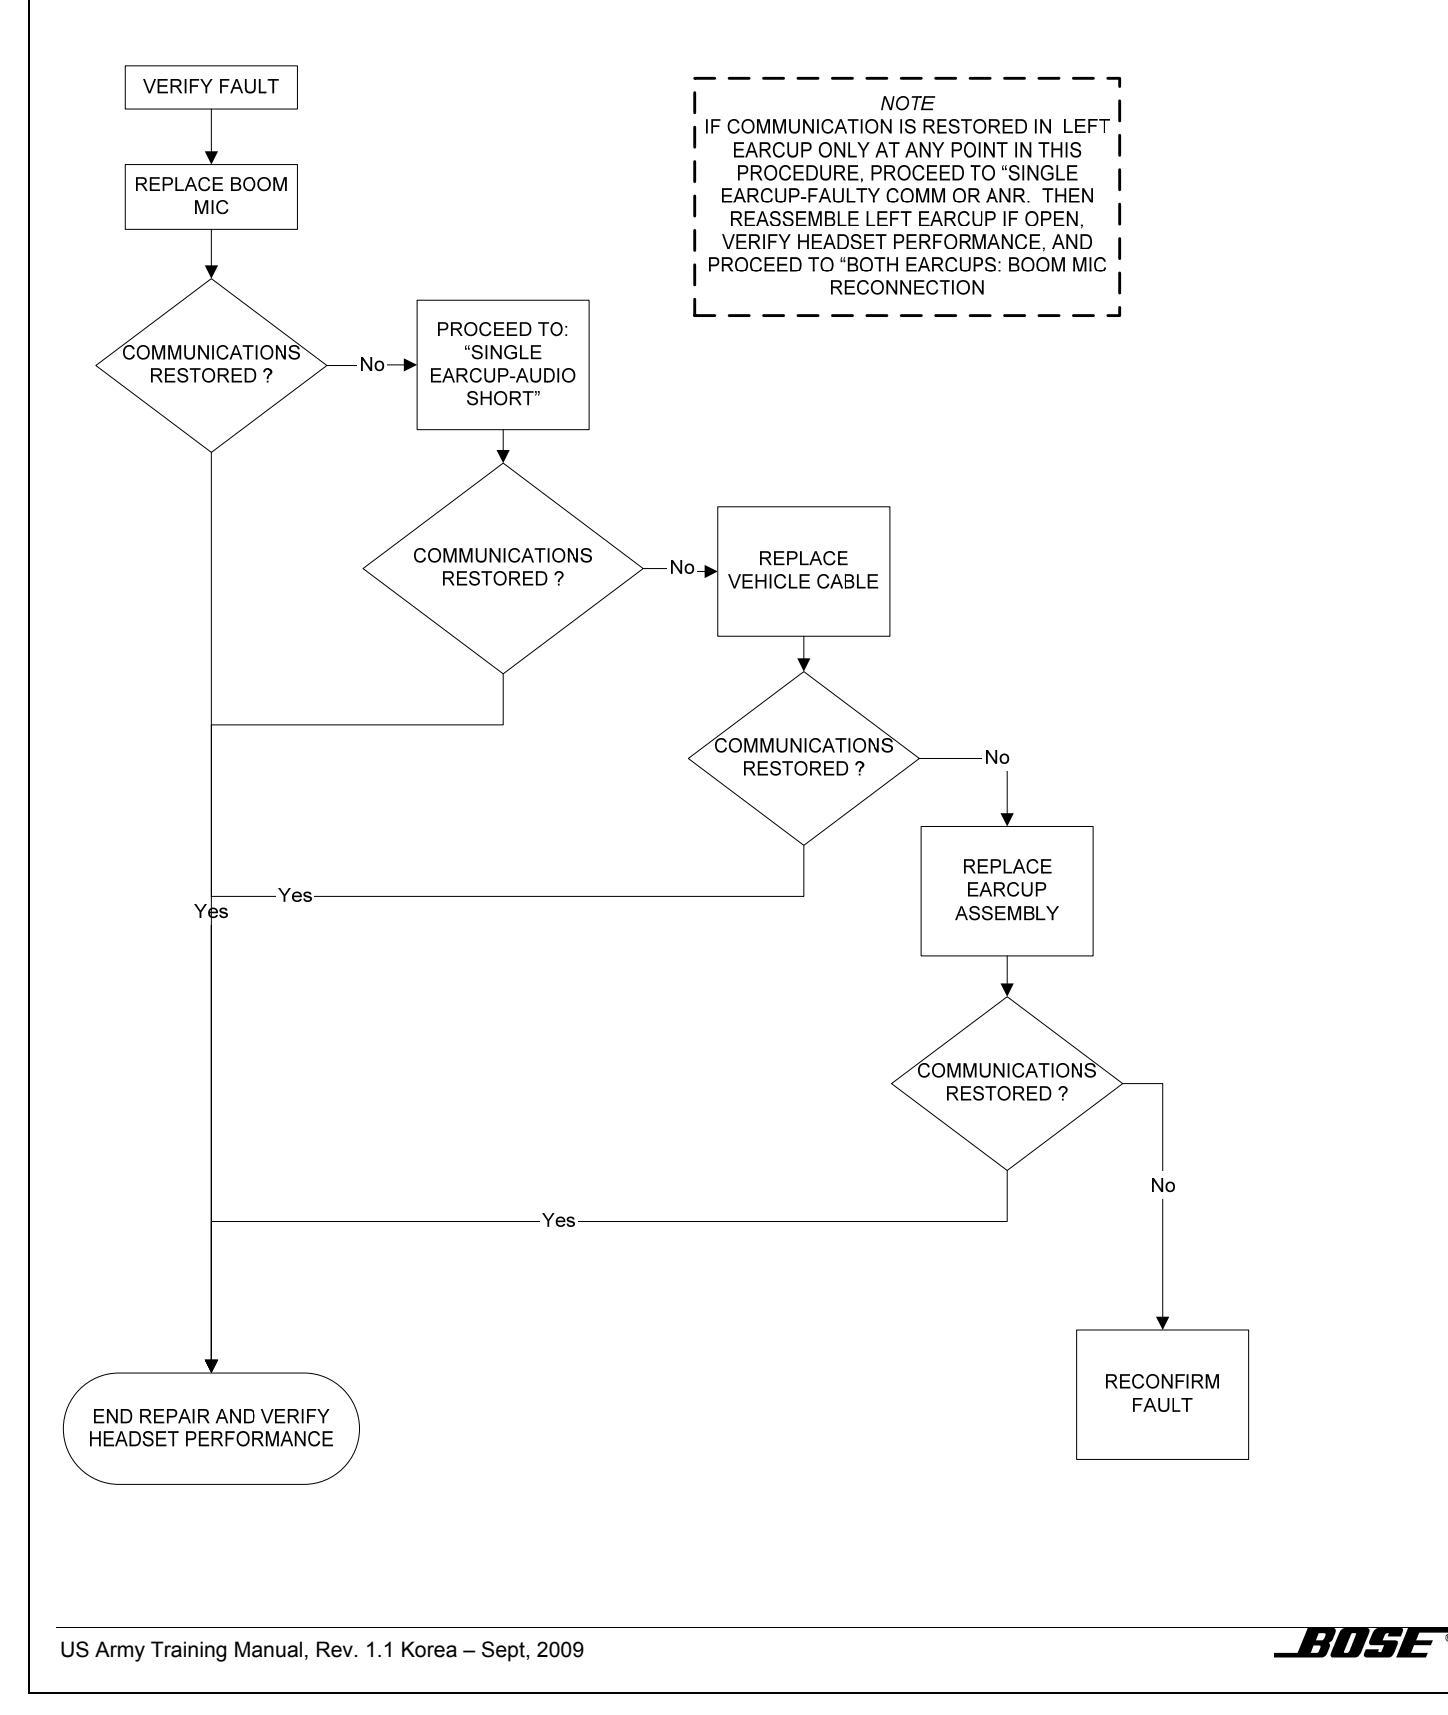
# BOTH EARCUPS: FAULTY COMMUNICATIONS, POWERED OR UNPOWERED

Both Earcups:	Verify fault.
Faulty Communication, Powered or Unpowered	Replace Boom Mic
	If communication is restored, proceed to <u>boom microphone</u> . End repair and verify headset performance.
	Otherwise, measure for audio short: NOTE: Disconnect test box from intercom. On the test box, jumper test points 1 and 5 together. Jumper test points 2,3,4. Measure resistance between TP 1 and TP 2.
	Normal DC resistance should be 500 ohms +/ If measured DC resistance is a short, proceed to <u>Both Earcups: Audio Short (pg. 36)</u> .
	NOTE: If communication is restored in Left earcup <u>ONLY</u> at any point in the following sequence, proceed to <u>Single Earcup: Faulty</u> <u>Communication or ANR</u> . Then reassemble Left earcup if open, verify communication, and proceed to <u>Both Earcups: boom</u> <u>microphone Reconnection</u> .
	Otherwise, replace vehicle cable. Continue to use external boom microphone until instructed otherwise.

NOTE: It may not be necessary to reassemble earcups before this fault is corrected, as long as they are handled gently enough to avoid stressing any of the headset wiring.
	If communication restored, reassemble Left earcup if open, verify communication, and proceed to <u>Both Earcups: boom microphone</u> <u>Reconnection</u> .
	Otherwise, replace earcup assembly.
	If communication restored, reassemble Left earcup if open, verify communication, and proceed to <u>Both Earcups: boom microphone</u> <u>Reconnection</u> .
	Otherwise, replace vehicle cable.
	If communication restored, reassemble Left earcup if open, verify communication, and proceed to <u>Both Earcups: boom microphone</u> <u>Reconnection</u> .
Both Earcups: boom microphone Reconnection	Reconnect boom microphone wires from the headset connector to the input of the Microphone Amplifier in the equipment setup.
	If communication remains restored, end repair; verify headset performance.

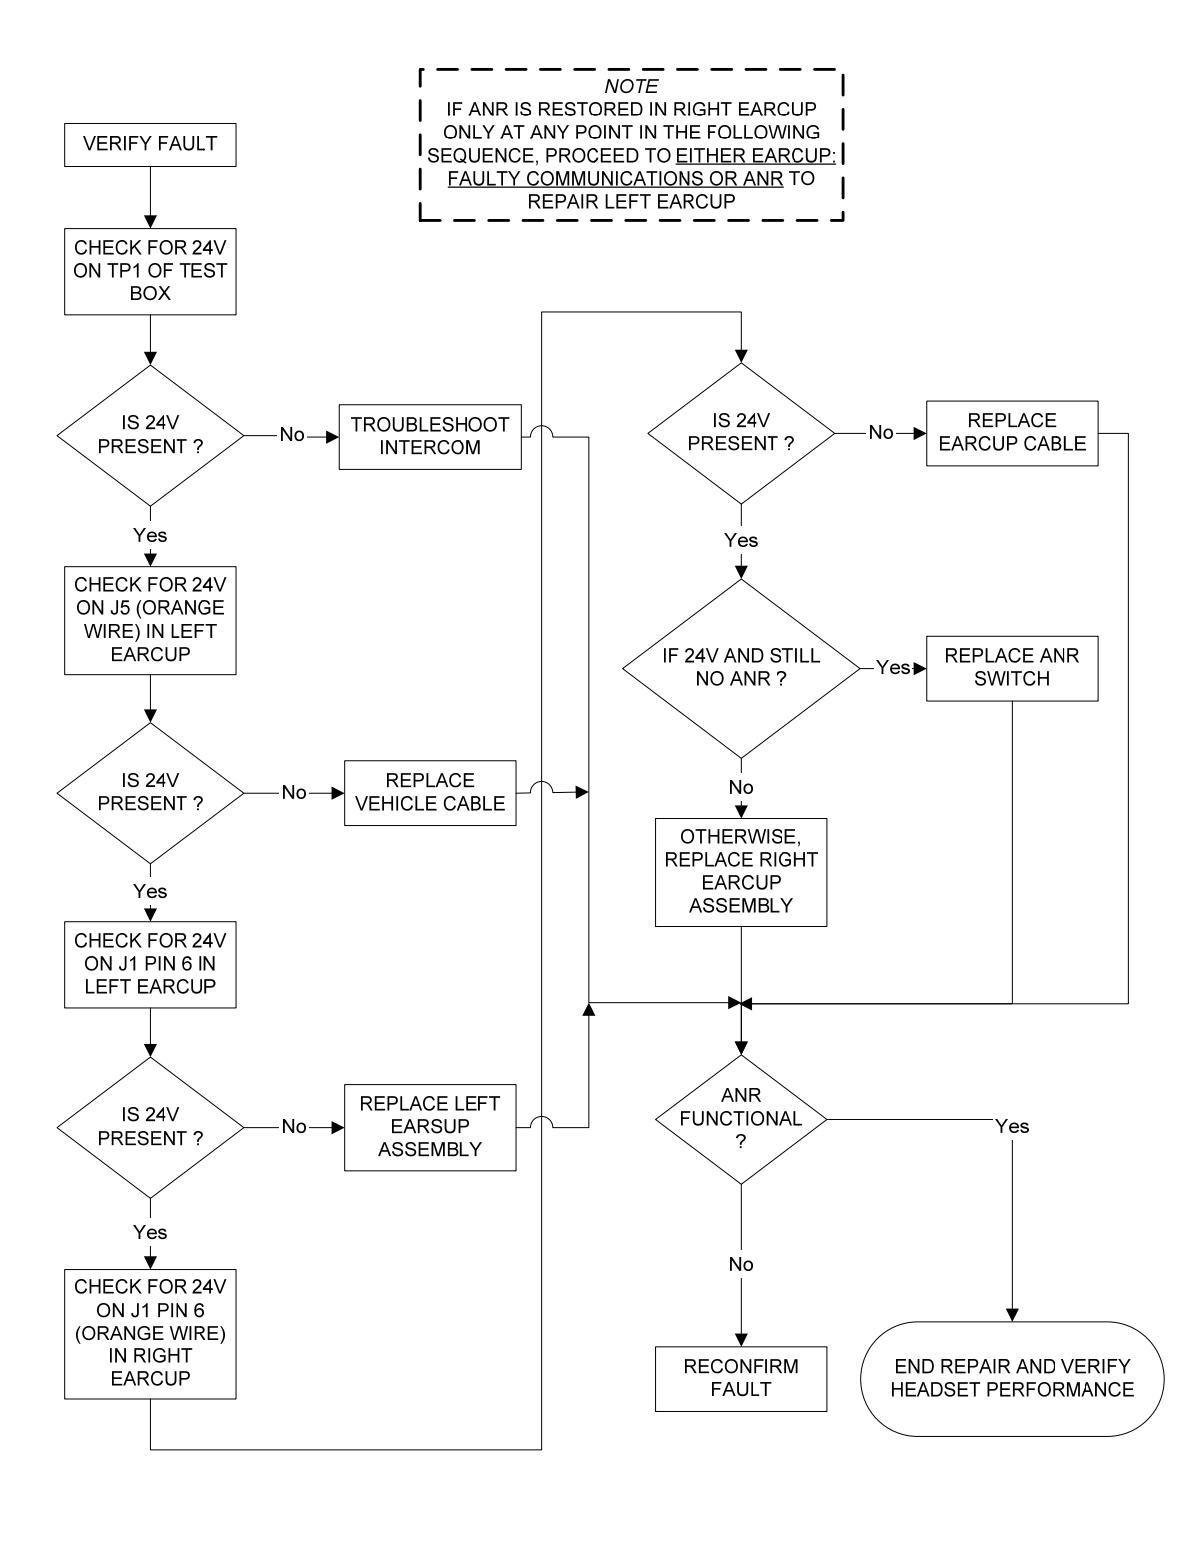
## **BOTH EARCUPS: FAULTY ANR**

Both Earcups:	Verify fault.	
Faulty ANR	NOTE: If ANR is restored in Right earcup <u>ONLY</u> at any point in the following sequence, proceed to section on <u>Either Earcup: Faulty</u> <u>Communication or ANR</u> to repair Left earcup.	
	If fault verified, replace ANR switch assembly in Right earcup.	
	NOTE: IT IS NECESSARY to reassemble earcups before checking repair of an ANR fault, because ANR depends on sealed earcups for its operation.	
	Test Set-Up:	
	Connect Headset to Test Box	
	Connect test box to intercom	
	Apply power	
	Check that 24v is present:	
	Check 24v on test box TP1. If not, troubleshoot intercom.	
	Else, Check $24v$ in left earcup, J5 (orange wire). If not, replace vehicle cable.	
	Else, Check 24v in left earcup, J1 pin 6. If not – replace left earcup.	
	Else, Check $24v$ in right earcup, J1, pin 6 (orange wire). If not replace cup-to-cup cable.	
	If 24v and still no ANR, replace ANR switch.

Else, replace right earcup assy.	
	When ANR restored, end repair; verify headset performance.

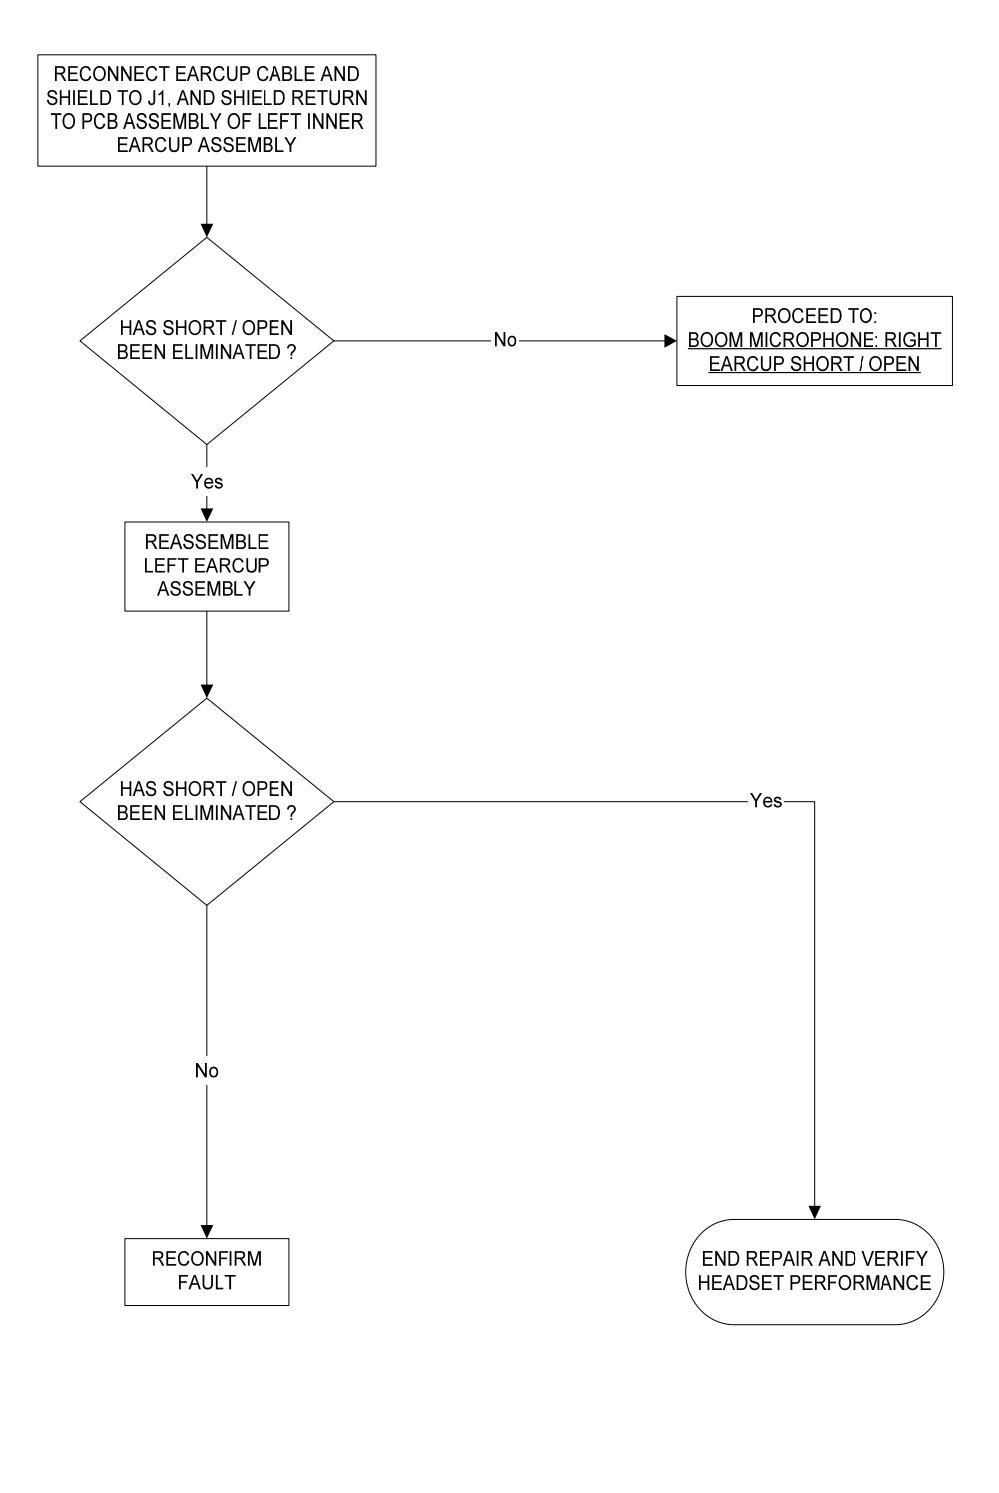
## BOOM MICROPHONE: BOOM MICROPHONE RECONNECTION

boom microphone: Earcup Reconnection	Reconnect earcup cable and shield to J1 and shield return of PCB assembly of Left inner earcup assembly.
	If short eliminated, reassemble Left earcup (being careful not to damage wires)
	Otherwise proceed to <u>boom microphone: Right Earcup Short/Open (pg. 67</u> .
	If short still eliminated after reassembly, end repair; verify headset performance.

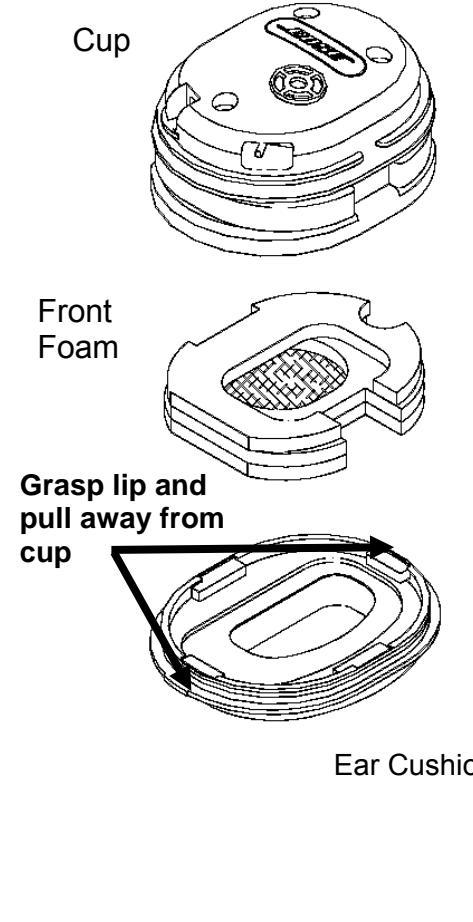
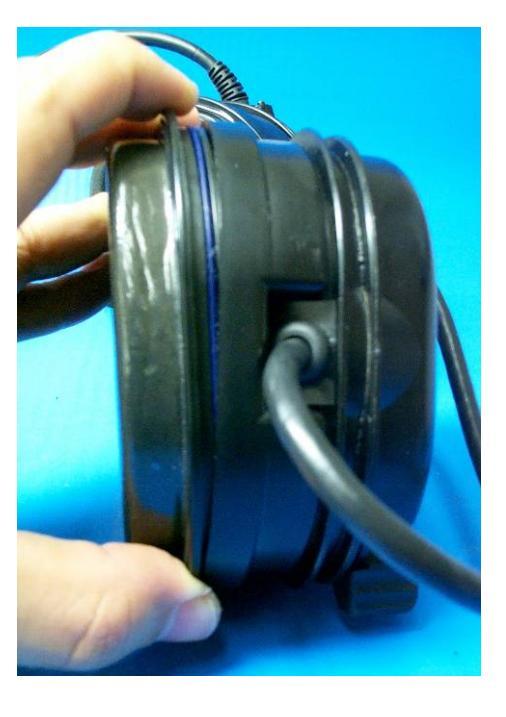
Ear Cushion and Front Foam Removal Figure 3-1

- 3.1 Removal
- 3.1.1 Grasp ear cushion assembly lengthwise with thumb and fingers hooked under ear cushion assembly lip.
- 3.1.2 Peel ear cushion assembly from earcup by tilting one end until free of earcup.
- 3.1.3 Remove front foam assembly from earcup to expose driver screen.
- 3.1.4 Pry off the damaged driver screen and discard.
- 3.2 Replacement
- 3.2.1 Position replacement driver screen on inner earcup and push into place using driver screen press fixture.
- 3.2.2 Insert front foam assembly into earcup.
- 3.2.3 Align ear cushion assembly on earcup.
- 3.2.4 Press ear cushion assembly firmly until secured in place to Velcro pads.

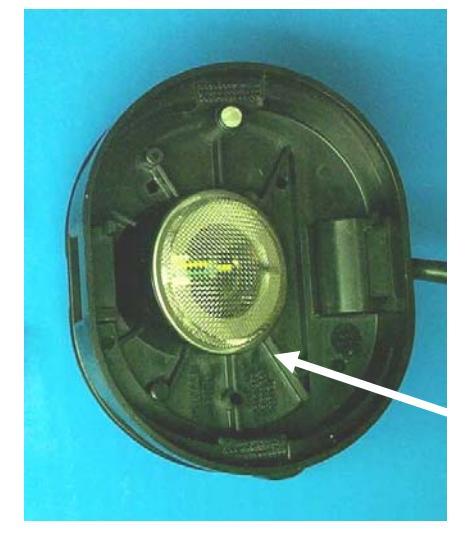
Figure 3-2

Driver Screen

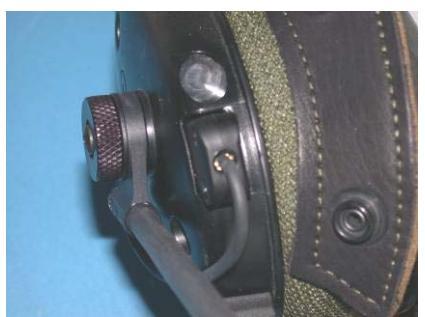
Figure 4-1

- 4.1 Removal
- 4.1.1 Disconnect the boom microphone connector from the earcup.
- 4.1.2 Using a cross-tipped screwdriver, remove screw securing mounting hardware to headset.
- 4.1.3 Unscrew knurled thumbnut.
- 4.1.4 Remove boom clamp and boom assembly by sliding off mounting post.

Removal of Boom microphone Hardware

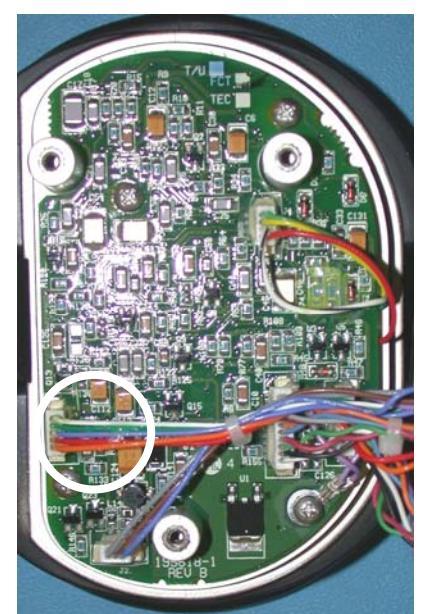
Plug PTT Switch Connector into Circuit Board at J3 and Seal Figure 5-3

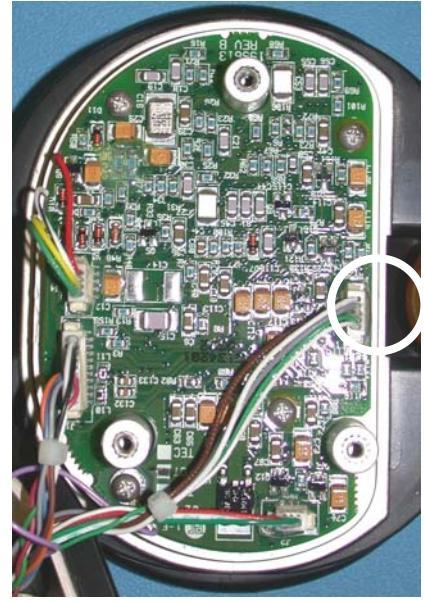
Plug ANR Switch Connector into Circuit Board at J3 and Seal

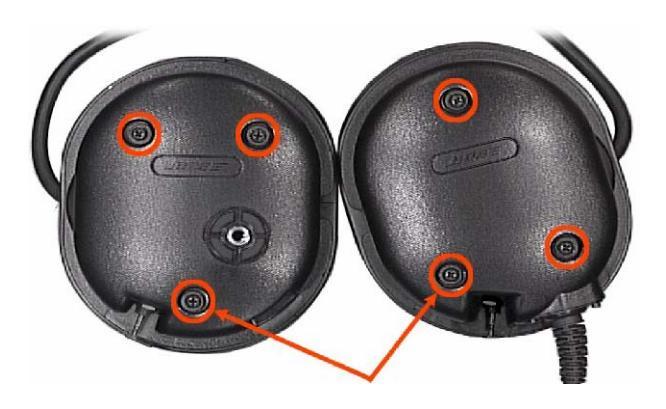
Sealing Screws Securing Outer and Inner Earcups Figure 6-1

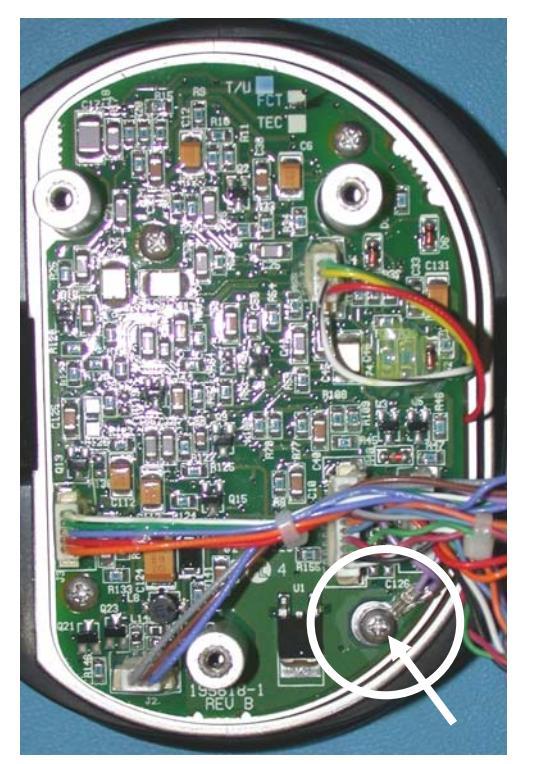
Screw on Circuit Board to Securing Ring Tongue Terminal
