# BOSE<sup>®</sup> PRODUCT IMPROVED COMBAT VEHICLE CREWMAN (PICVC) ACTIVE NOISE REDUCTION HEADSET USE AND MAINTENANCE MANUAL

US Army Training Manual, Rev. 1.0 – Oct, 2007

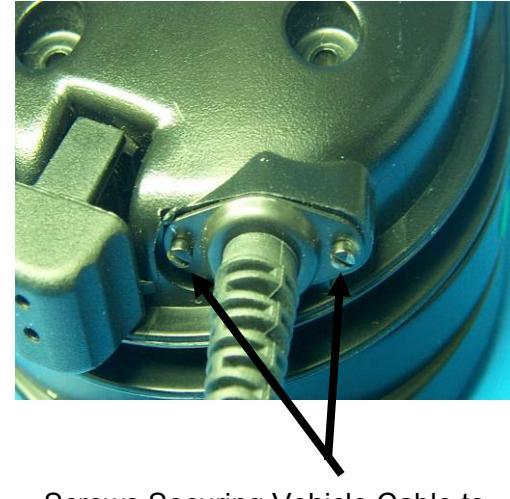
Figure 6-2

Screws Securing Vehicle Cable to Earcup

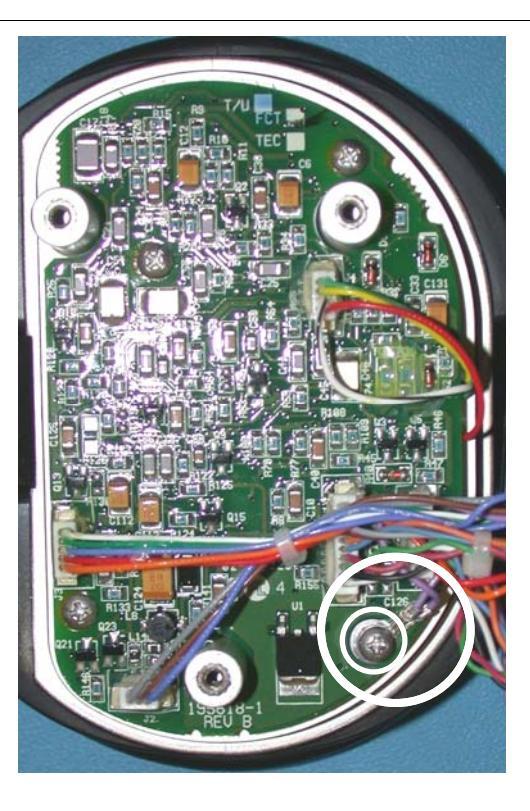
Figure 6-3

Plug Vehicle Cable Connector into Circuit Board at J5 and Seal Connect Ring Tongue Terminal to Screw

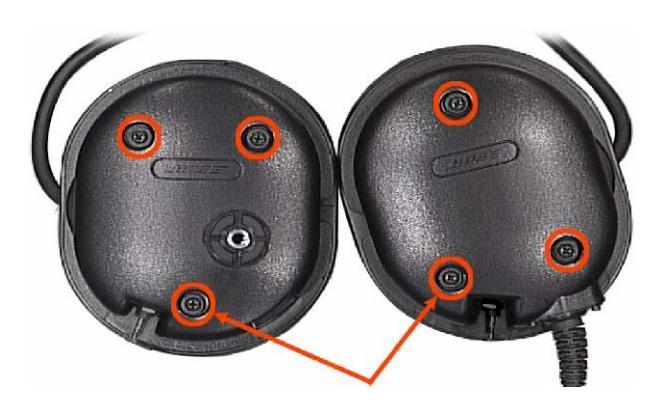
- 7.2.3 Secure ring tongue terminals from vehicle cable and earcup to earcup cable in place using cross-tipped screwdriver and torque screw to 2.0 +/- .2 in-lbs. (23 +/- 2 g-m)
- 7.2.4 Assemble the inner and outer earcups ensuring no wires are pinched. When assembling the inner and outer cup assemblies, be sure to twist the wiring 1 ½ to 2 turns such that the cable fits neatly into the earcup when assembled.
- 7.2.5 Secure outer earcup in place using three sealing screws. Torque screws to 3.0 +/- .25 in-lbs. (35 +/- 3 g-m)

Sealing Screws Securing Outer and Inner Earcups

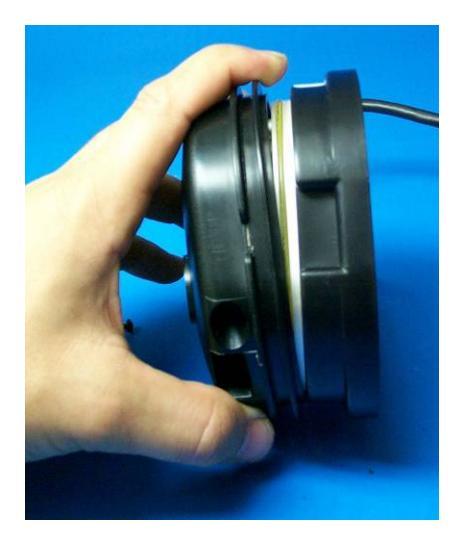
Separating Outer and Inner Cup Assemblies

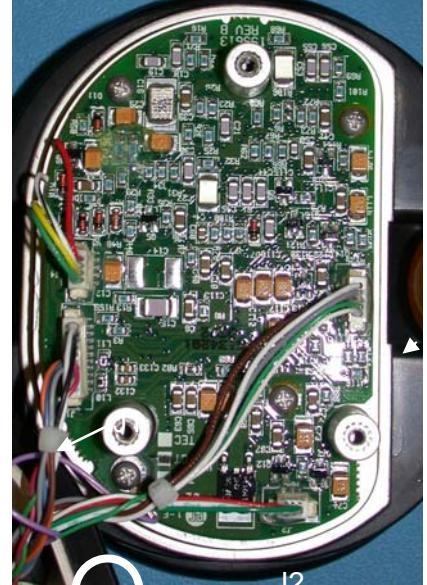
et Plug Connectors into Circuit Board at J1, J2, and J3 and Seal rew Connect Ring Tongue Terminal to Screw Figure 7-2

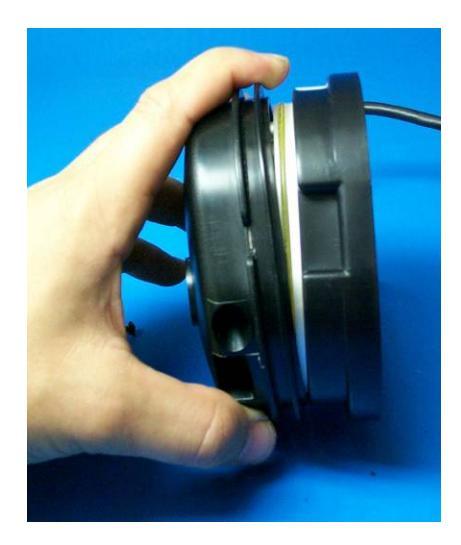
Separating Outer and Inner Cup Assemblies

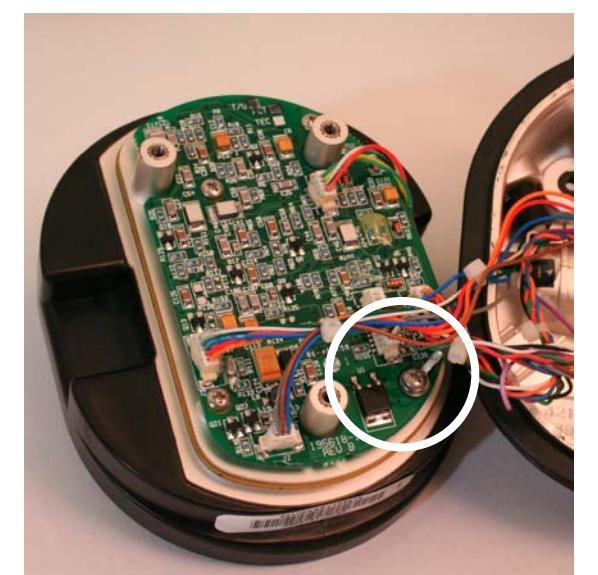
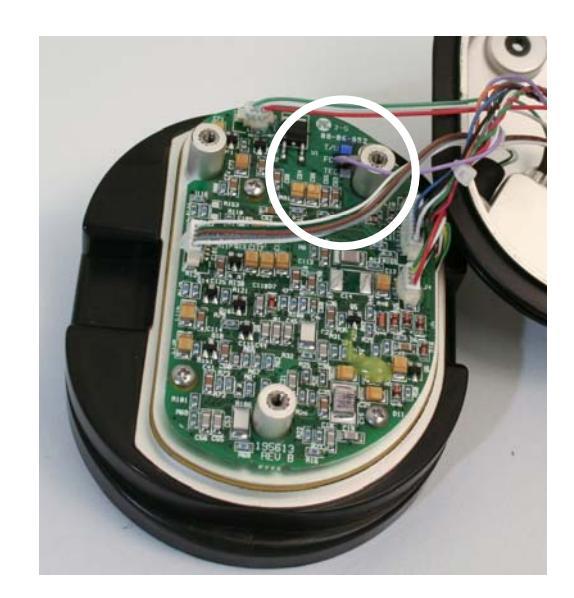
Plug Earcup Cable Connector into Circuit Board Plug Earcup Cable Connector into Circuit Board at J1 and Seal Connect Ring Tongue Terminal to Screw Figure 8-3

at J1 and Seal Connect Ring Tongue Terminal to Screw

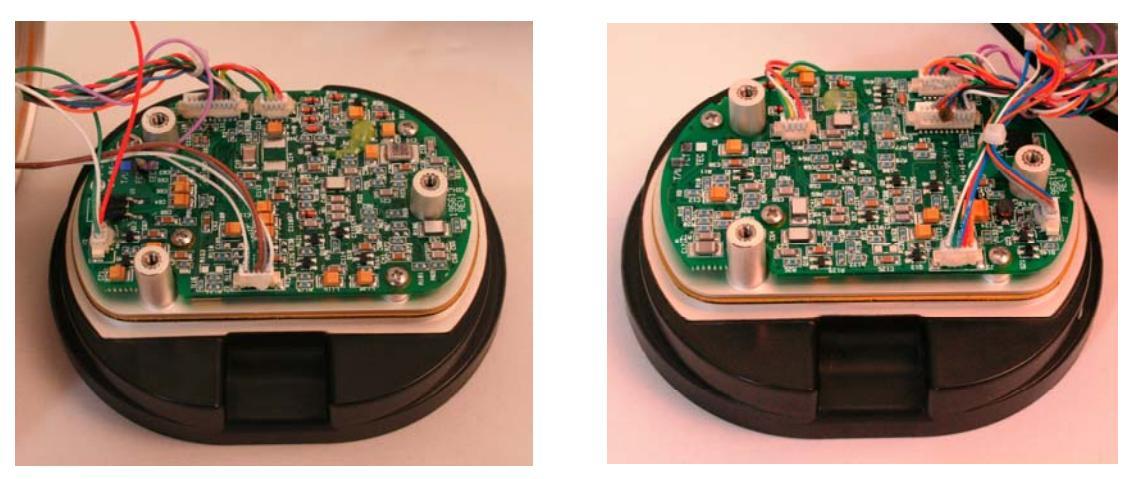
Figure 9-3

Secure Connection to Circuit Board and Seal Connect Ring Tongue Terminals to Screw
